# On Track All the Way to Completion: The Loyalsock Creek Bridge Replacement

by Jason Shura, PE, and Brian Wiser, PE, Keller Engineers, Inc., Hollidaysburg, PA;  
John Conrad, PE, Railroad Consulting Engineer, Tyrone, PA, **ASHE Altoona Section**

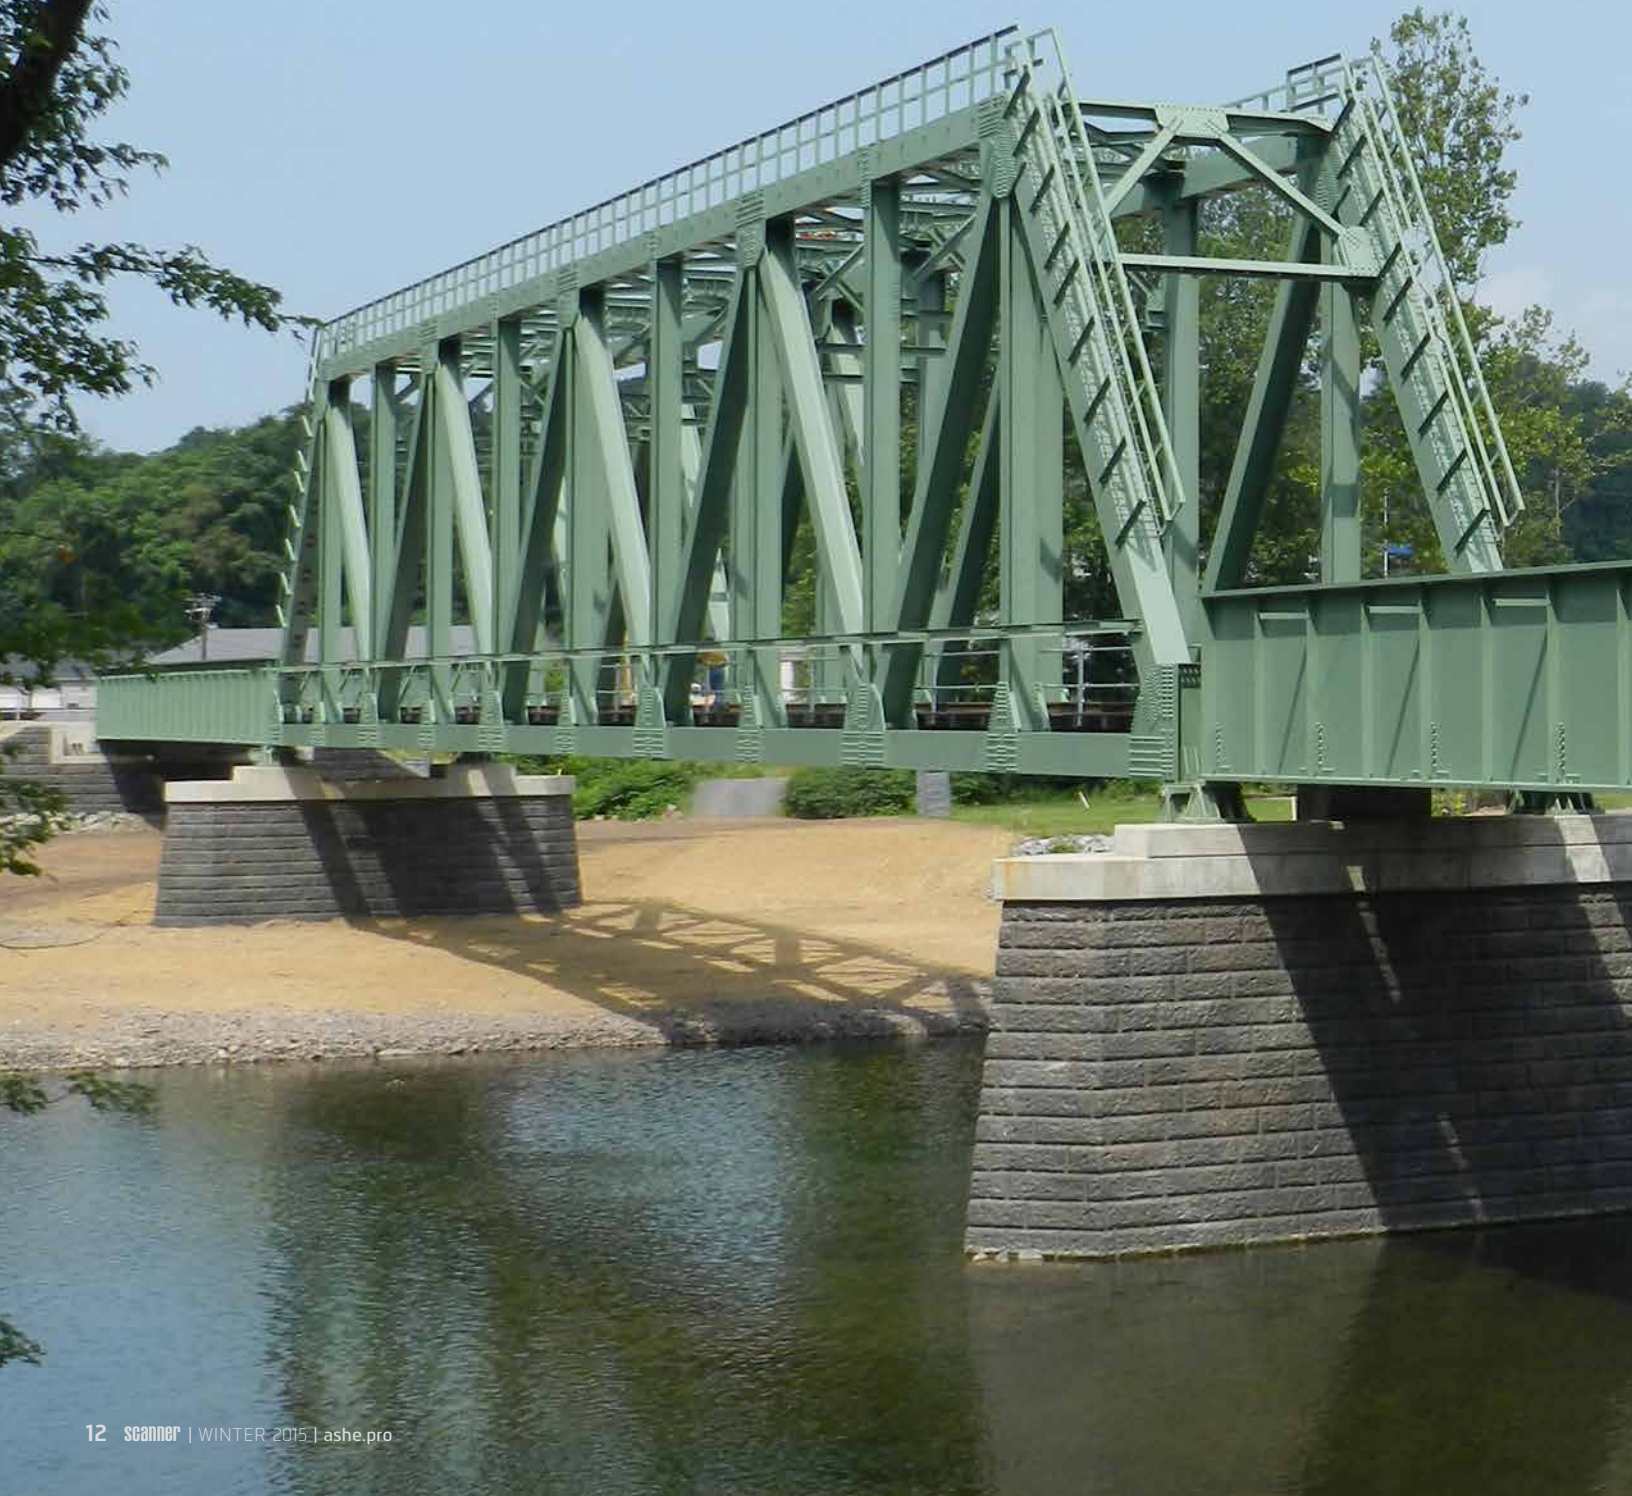
A three-span structure with steel through-girder approach spans and a through truss main span was selected to minimize the number of piers in the creek and to allow work to be completed under the electric transmission lines. Tropical Storm Lee, which exceeded the 100-year storm, was used as the design storm. The resulting raise in track was nearly three feet, requiring almost one-half mile

of track realignment. An open deck system was selected to minimize the required track raise and to permit access to the steel floorsystem for maintenance. Given that the cause of the original bridge failure was stream scour and undermining of the piers, all foundations were supported on steel piles driven to bedrock, even though bearing soils could have supported spread footings.
